Tivoli Mfg. Ltd.

Safety Bulletin

Bulletin No: SOSA019A (Supersedes SOSA019)

Purpose: Procedures for reopening Spin Out Ride

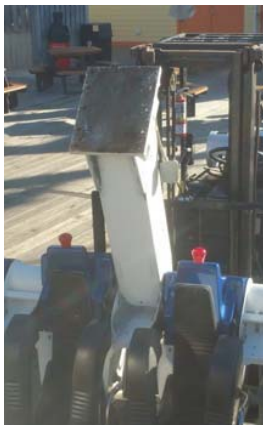
Original Design

- The Spin Out sweep bolt plate was manufactured without and access hole in the center of the plate, thus protecting the interior of the support tube from the outside elements.
- Latter models were constructed with a 2 pin construction also protecting the interior from the elements.

Tivoli Mfg. requires that all Spin Out owners follow the inspection procedure outlined in the KMG bulletin FRB24-SB008 with the exception of Procedure A. The interior of the support tube is not accessible.

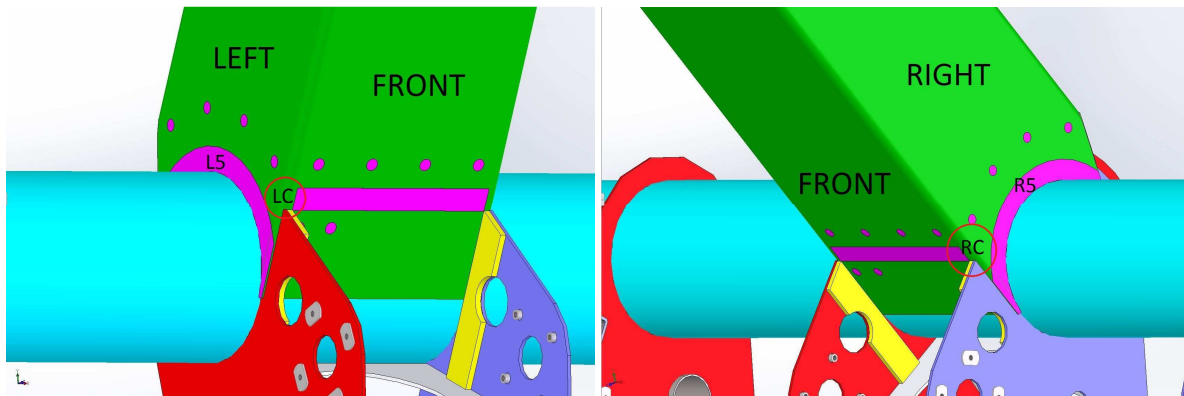
Areas:

- Gain access to all four sides of the gondola support beam and around the joint. The secondary lock solenoid can be left in place.
- Remove all parts and paint in below mentioned areas L5 and R5 on both sides of the beam joint and on both corners LC and RC of the support beam joint:

- Test for cracks using magnetic testing following ISO 17638.

Accepted: Magnetic test results are meeting class 1 criteria as per ISO 23278.

Rejected: Magnetic test results are not meeting class 1 criteria as per ISO 23278.

Do NOT return ride to service.

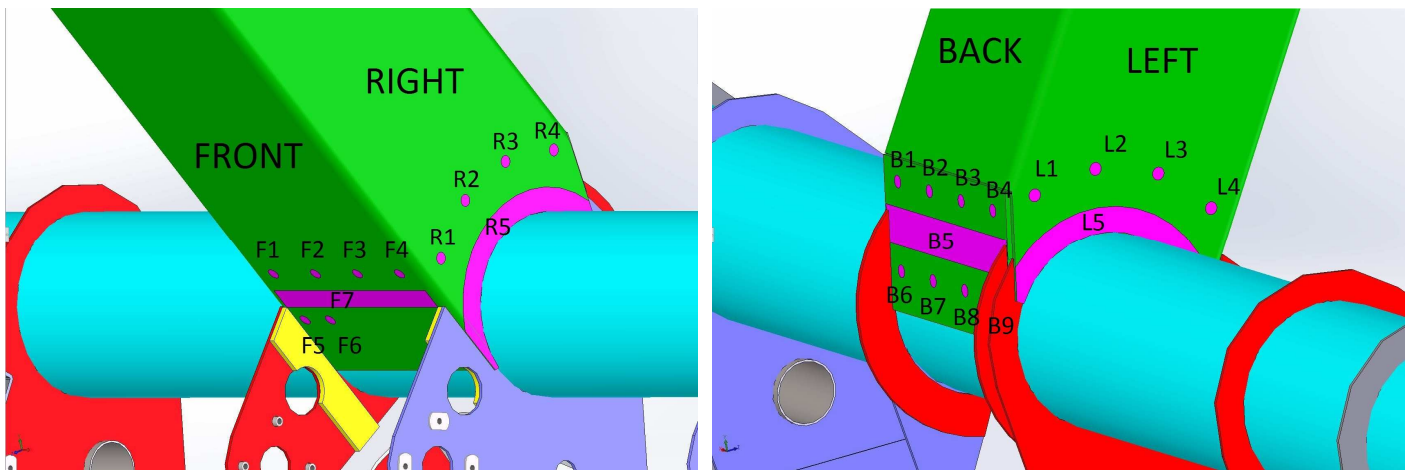
Areas:

1. Remove all parts and paint in below mentioned areas L, R, F, B following the specific locations in below drawings.
2. Do a wall thickness measurement in all numbered areas L, R, F, B following the specific locations in below drawings.
 Applicable standard for inspection: EN14127. Equipment: Ultrasonic thickness measurement equipment with minimum an A-scan. Probe: GE / Krautkrämer DA312, Trusonic TS-400 or equivalent.

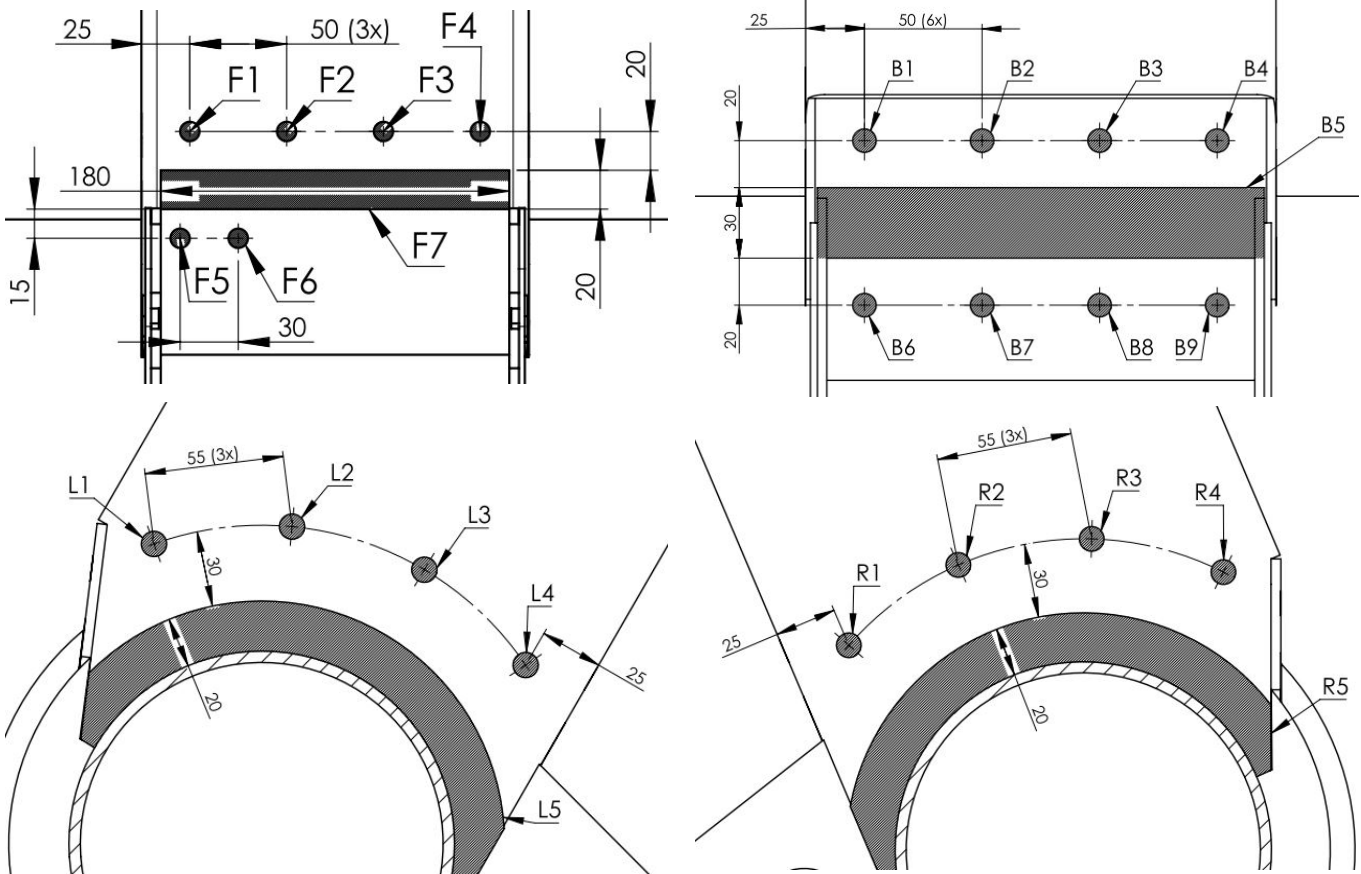
Location dimensions (measurements in metric unit mm):

Accepted: All measured area meet a wall thickness ≥ 3 mm.
 Rejected: One or more measured areas have a wall thickness less than 3mm.
Do NOT return ride to service.

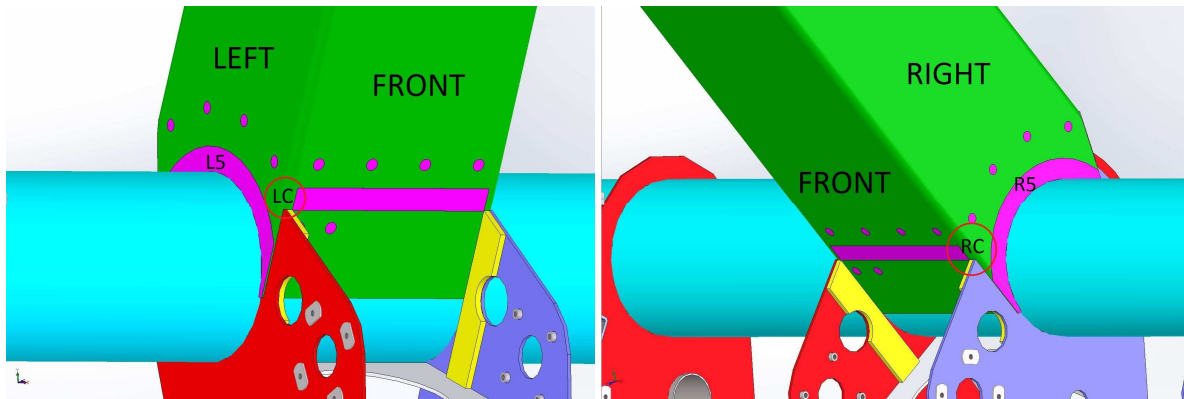
1. Gain access to areas described in below images.
2. Visually inspect areas L5 and R5 and corners LC and RC, looking for cracks. Applicable standard for inspection is ISO 17637 and acceptance criteria following ISO 5817 acceptance class B.

Accepted: Visual test results are meeting class B criteria as per ISO 5817.
 Rejected: Visual test results are not meeting class B criteria as per ISO 5817.
Do NOT return ride to service and consult KMG.
