From : Engineering department
Subject : Service Bulletin
Order no. : Ride serial FRB-24-XX
Our reference : Afterburner Ride Service Bulletin

Bulletin No.: FRB-SB006
Ride: Afterburner by KMG International BV
Relative Rides: All Models

Regarding: NDT testing of swing arm weld area

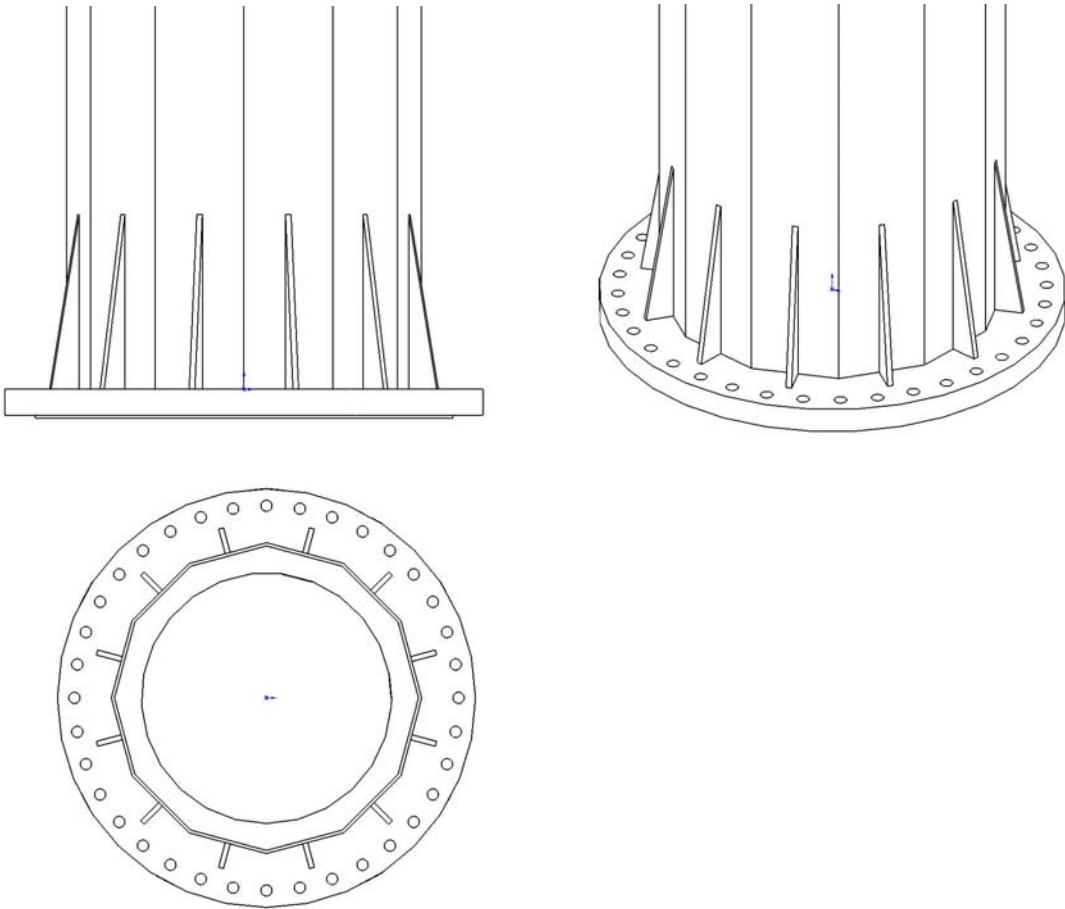
Reinforcements are made by welding 12 gusset plates in a circular patten around the tube, on the center of each side of the tube's sides.

Dimensions of the gusset plates are 300mm long, 50mm wide and with a thickness of 10mm. Material is St.52-3 or S355.

All rides need to have the affected area to be reinforced with gusset plates according to attached dimensions, material specifications and welding instructions.

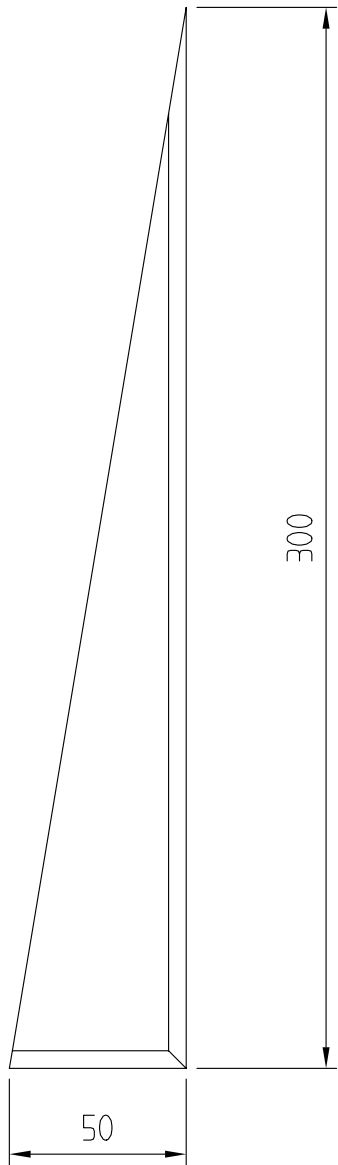
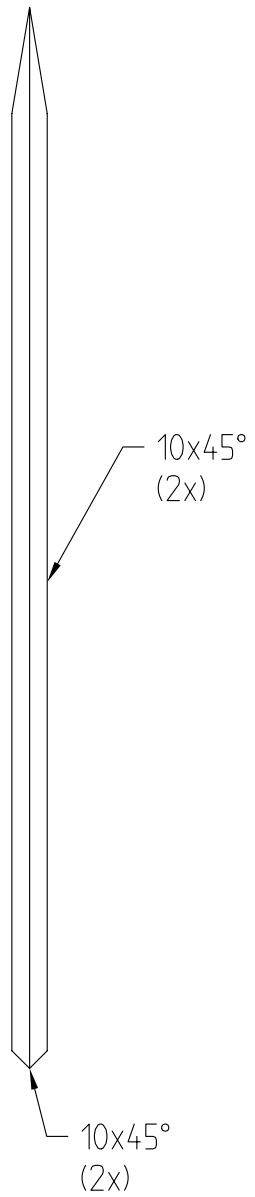
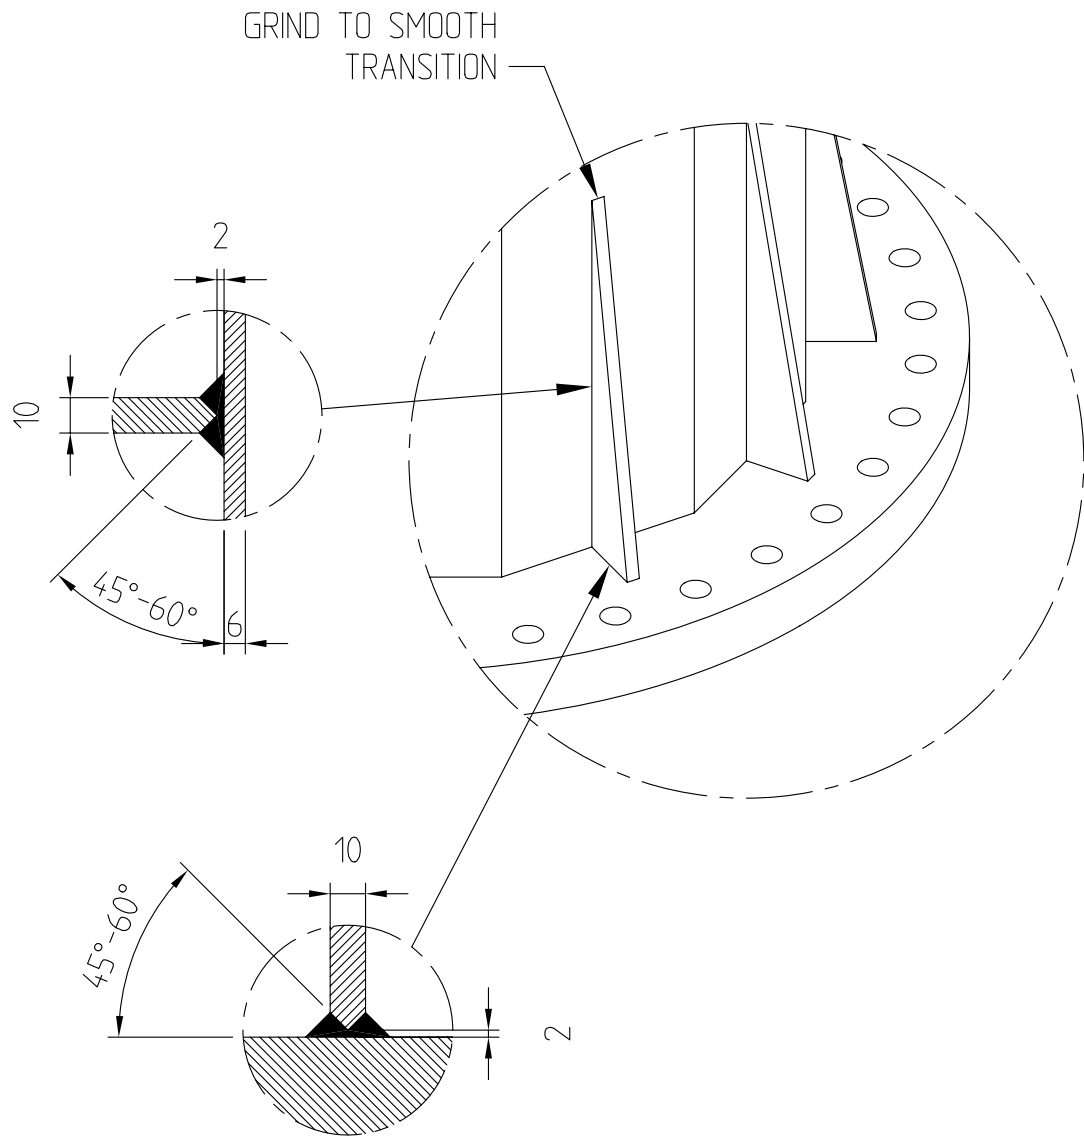
In order to weld, the gondola bearing must be completely removed. After cleaning the weld area from paint and dirt the gusset plates should be fully welded. The ends of the welds should be smooth finished by grinding. The 50mm flange should be pre-heated to at least 150°C. Welding details are attached on the end of this document.
